The Fallacy of Monitoring Surge Voltages: SPDs and PCs Galore!

Reprinted from Proceedings. PQA '99 Conference

Abstract

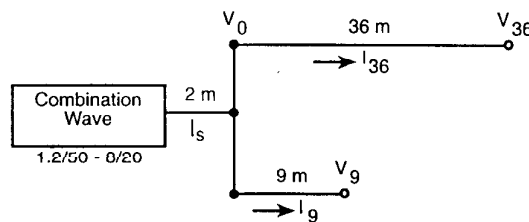
Figure 1 - Upside-Down House branch circuits

To illustrate the effect of nonlinear SPDs as well as linear capacitors connected across the mains, the Power Electronics Applications Center (PEAC) “Upside-Down House” [Key et al., 1994] was used to inject surges into the service entrance of the Upside Down House with various combinations of SPDs and/or personal computer (PC) power supplies connected at the end of two branch circuits, one 9-m long, the other 36-m long. In Figure 1, currents in the branches and voltages at the nodes are identified respectively as I_s , I_9 , I_{36} , and V_0 , V_9 , V_{36} . The charging voltage setting of the Combination Wave surge generator was kept constant to provide a 2 kV, 1.2/50 μ s open-circuit voltage (OCV). In a second series of experiments, the setting was increased to 4 kV. This second series, not reported here in detail because of limited space, confirmed the expected nonlinear response of varistors and the linear response for capacitors only.

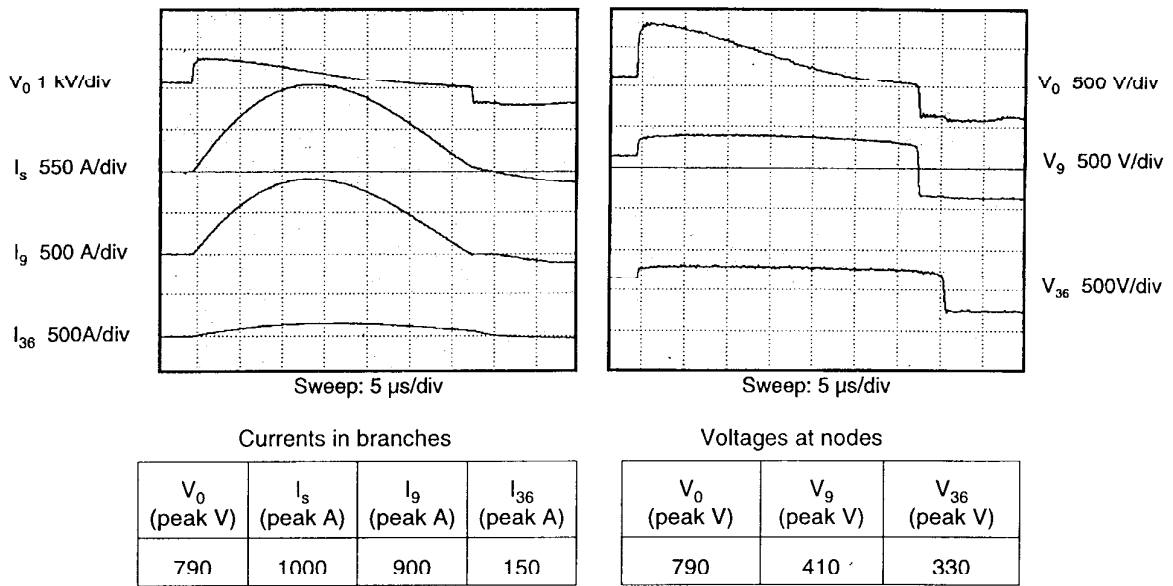
Figure 2 - Typical recordings¹ made during the first experiment – SPDs only.

Given the known and predictable behavior of multiple SPDs — often reported in the literature to the point that bibliographic citations would take several lines to list all of them — this part of the experiment was performed only to provide a baseline. Metal-oxide varistors (MOVs) rated 150 V, 20 mm diameter, were used for this experiment. To record all interesting currents and voltages, two shots are necessary when using the 4-channel digital signal analyzer; therefore each oscillogram in the figures contains the trace of V_0 to serve as a common reference (Figure 2).

In Figure 2, the current traces (left oscillogram) show the unequal sharing between the two MOVs, reflecting the difference in the inductance of the two branch circuits. Because the peaks of the two branch-circuit currents are not simultaneous (the current in the longer branch circuit takes longer to build up) their sum seems to exceed the peak of the injected current, I_s .

The voltage traces (right oscillogram) show how the voltage at the service entrance, V_0 , is mitigated from the 2 kV open-circuit voltage supplied by the generator that would propagate without attenuation in the absence of a surge-mitigating device [Martzloff et al., 1986]. This voltage V_0 is the sum of the clamping performed by the varistor at the node V_g , and the inductive voltage drop in the 9-m long connection. Note that this inductive voltage is additive during the rise of the current I_g , and subtractive during the fall, hence the apparent “overshoot” in the trace of V_0 , compared to the flat-top trace of the varistor at V_g . The voltages at V_g and V_{36} are the typical clamping voltages of the MOVs corresponding to the current they carry.

In a subsequent experiment with a 4 kV open-circuit voltage setting of the generator (twice the value of Figure 2, but not reported here in detail because of limited space), the voltages across the varistors, predictably, were not substantially increased. However, the substantially increased current in the 9-m long branch circuit (from 1000 A to 2800 A, resulting from the nonlinear response of the varistor) produced an increased inductive effect to the point that the voltage at the service entrance was raised to 1300 V from the 790 V recorded for the case of Figure 2. Table 1, at the end of this section, presents a summary of the peak values recorded in the various combinations of components, branch circuits, and amplitudes of the injected surge.

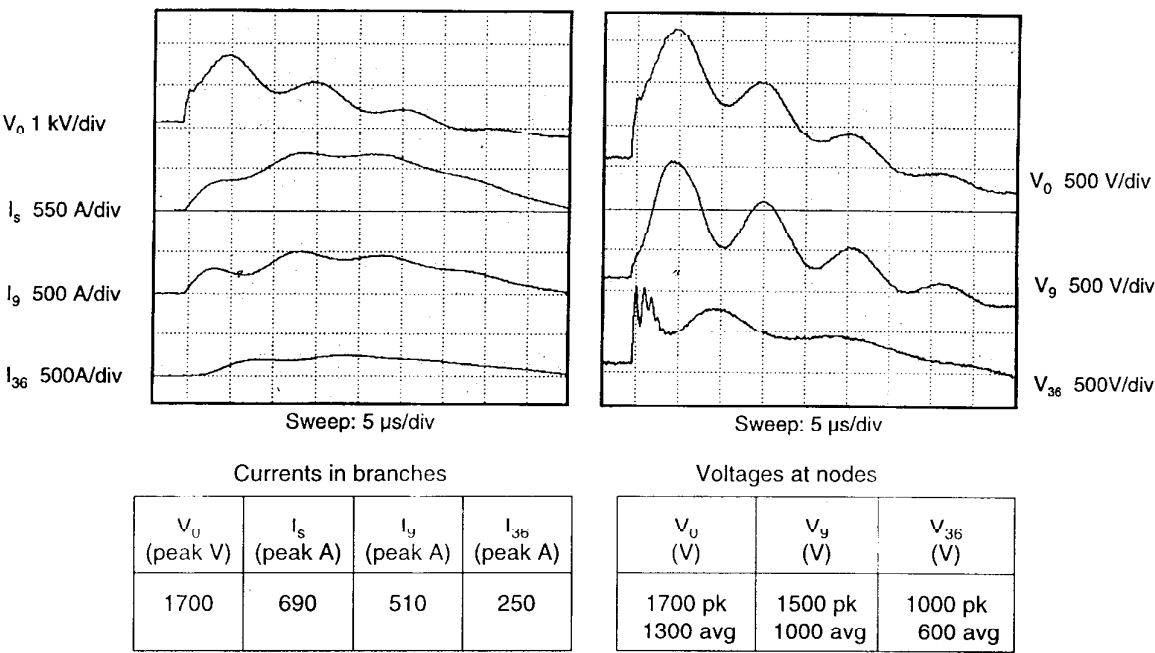
Figure 3 - Typical recordings made during the second experiment – Capacitors only

In a second set of experiments, less easily predictable would be the behavior of the still all-linear circuit involving the capacitors of a PC power supply (440 μ F each in this experiment) when receiving a surge originating from the complex RLC wave-shaping network of a Combination Wave surge generator (Figure 3).

In Figure 3, the voltage at the service entrance, V_0 , is mitigated from the 2 kV open-circuit voltage supplied by the generator. However, because of the interaction between the RLC components in the wave-shaping network of the Combination Wave generator on the one hand, and the capacitances of the PC power supplies and inductances of the branch circuits on the other hand, this voltage rings around an average voltage level of 1300 V, reaching a peak of 1700 V. To reflect this situation, the tabulation of the voltages in the figure shows two lines, peak and average. Thus, the mitigation effect is degraded by the ringing. Nevertheless, one can expect that as more PCs would be added, the ringing frequency would become lower and the voltage peaks lower.

Experiments 2 and 3 (Figures 3 and 4) do show decreasing levels of voltage surges at various points of the Upside Down House, compared to the open-circuit conditions. However, the interactions between the capacitors of the generator RLC wave-shaping network on the one hand, and the PC capacitors on the other hand, make detailed interpretation of the waveforms tedious and beyond the scope of our illustrative examples. Numerical modeling with a current source, as reported in the following section, avoids this interaction and provides further evidence on the “PCs Galore” effect. For readers interested in the details, Table 1 documents the results concerning peak voltages noted from the oscillograms kept on file but not reproduced here. Readers interested primarily in the big picture may skip a close examination of this table.

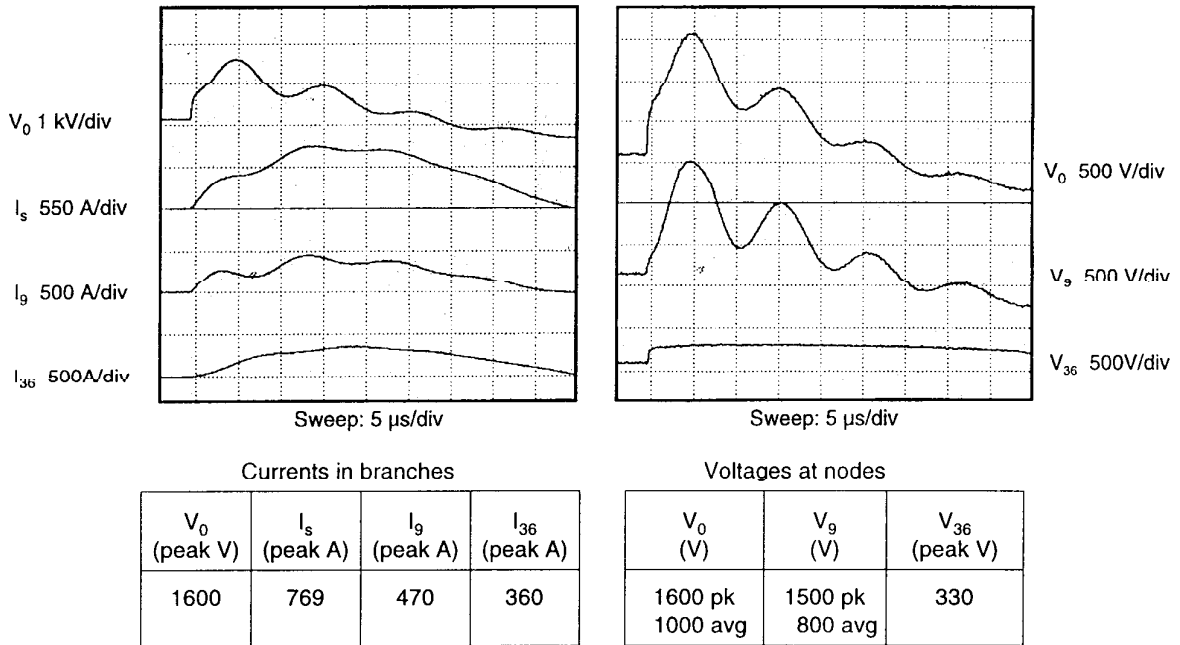
Figure 4 - Typical recordings made during the third experiment – capacitor and MOV.

In a third set of experiments, a capacitor was connected at the end of the 9-m branch circuit and an MOV was connected at the end of the 36-m branch circuit. Interest in this particular configuration was motivated by the desire to show how an MOV would mitigate the ringing that was observed in the preceding experiment at the end of the 36-m line (V_{36} in Figure 3).

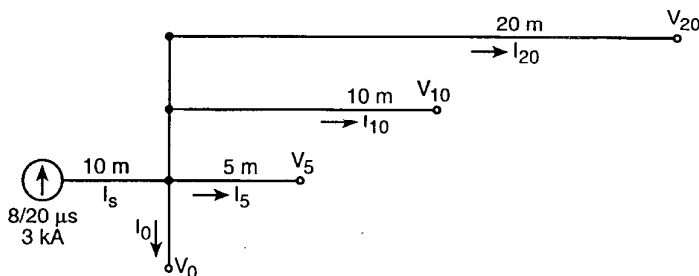
Figure 5 - Service drop and branch circuits for modeling combinations

In a series of modeling runs similar to the combinations of the experimental measurements, the model used the circuit of Figure 5. A current source feeds a fixed current surge via a common service drop to the panel bus of the service entrance, where three branch circuits made of 2-mm diameter conductors (#12 AWG) take off, with length of respectively 5 m, 10 m, and 20 m. The choice of these lengths was based on curiosity about the effect of the long distance connection (and thus an effect that might be delayed or degraded) to the immediate occurrence of an overvoltage at the end of shorter branch circuits. The currents in the circuit are identified in Figure 5 respectively as I_s , I_0 , I_5 , I_{10} , and I_{20} , with the node voltages at the service bus and branch circuit ends respectively as V_0 , V_5 , V_{10} , and V_{20} .

As in our previous modeling applications, the EMTP program [EPRI, 1989] was used. To avoid computational artifacts, a finite 10 kΩ resistance was always postulated at the ends of all branch circuits, whether these were left in “open” or “loaded” condition. The loads that were modeled included combinations of SPDs, capacitors, and 100 Ω resistors. The SPDs were all 20-mm diameter, 130-V rated MOVs. The capacitors included a capacitance of 440 μF and a series resistance (“ESR”) of 0.25 Ω to represent an electrolytic capacitor. Initial conditions for the models stipulated an initial charge on the capacitor to represent the normal condition of the DC link. The 100 Ω resistor was selected as a typical value for a 150-W power-consuming appliance connected at the end of the branch circuit.

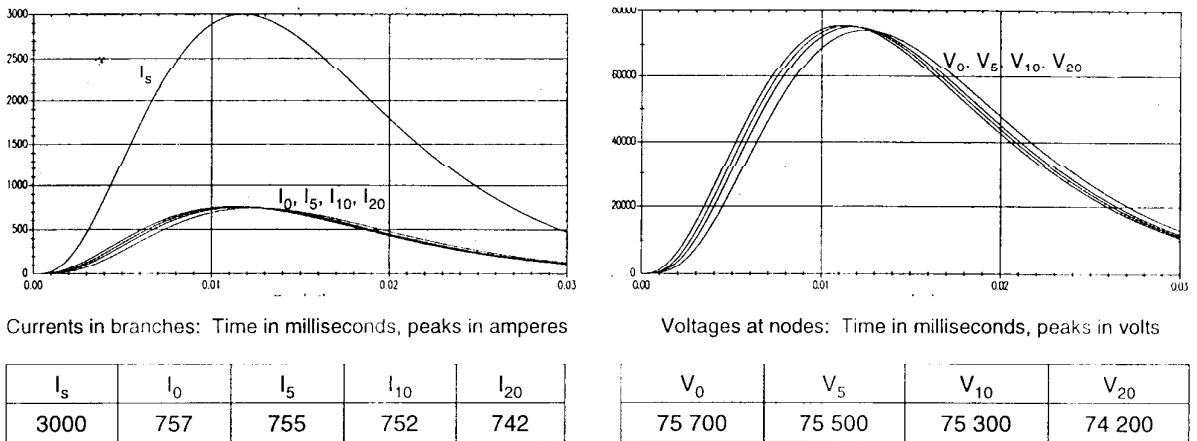
Figure 6 - Currents and voltages for the baseline case of $100\ \Omega$ loads without SPDs

Just to illustrate the point of a readily predictable behavior of a purely linear circuit, Figure 6 shows the voltages and currents for the case of $100\ \Omega$ loads confronted with a current source. Compared with the $100\ \Omega$ load at the end of the branch circuits, the series impedance has a very small effect and the impinging surge current I_s divides almost equally ($3000\ \text{A} / 4 = 750\ \text{A}$) in the nearly identical four branches I_0 , I_5 , I_{10} , and I_{20} (I_0 being the current in the service entrance ‘branch’, with a length of 0). Thus, the voltage developed by this $750\ \text{A}$ current across $100\ \Omega$ would simply be expected to be $75\ 000\ \text{V}$ (seventy five thousand volts). We say “would be expected” because, of course, the insulation level of a real-world low-voltage insulation cannot withstand such a voltage. The result of this theoretical case is another illustration of the theme “More Begets Less,” according to which a high-amplitude, steep-front surge cannot propagate in branch circuits because a flashover will occur at the origin [Mansoor et al., 1998].

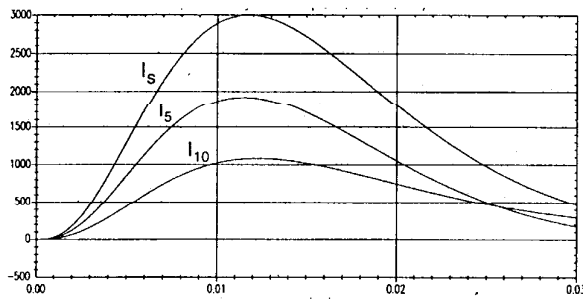
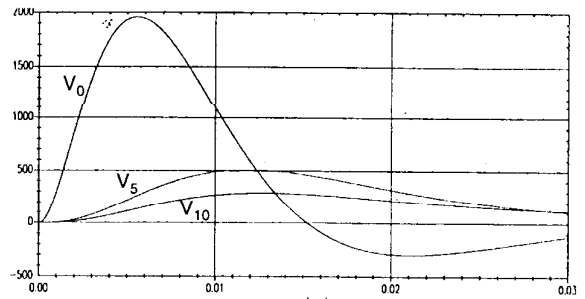
Figure 7 - Currents and voltages for the case of two PCs without SPDs

Figure 7 shows the example of two PCs, one at the end of the 5-m branch circuit, the other at the end of the 10-m branch circuit: the surge current is shared (unequally) between the two capacitors, with a corresponding decrease of the voltage level at each DC link, and also a reduction of the voltage at the open end (unprotected) of the 20-m branch circuit. This example shows the beginning of the “PCs Galore !” effect. Several intermediate and further steps were modeled by adding combinations of surge-mitigating devices to build our case file and confirm the expected effects, but we will spare the reader from a tedious recitation.

- The unequal division of the currents I_s and I_{10} reflects the effect of the larger impedance of the 10-m branch circuit, compared to the 5-m branch circuit.
- Substantial mitigation is obtained at the nodes V_5 and V_{10} , as a result of the filter-like action of the line inductance and the capacitance of the PC power supply.
- The voltage surge developed at the node V_0 propagates, unabated, to the end of the open-circuited 20-m branch circuit, a reminder that the notion of voltage surges being attenuated as they propagate in building wiring [IEC Report 664, 1980] was incorrect.

Currents in branches: Time in milliseconds, peaks in amperes

I_s	I_0	I_5	I_{10}	I_{20}
3000	0	1920	1080	0

Voltages at nodes: Time in milliseconds, peaks in volts

V_0	V_5	V_{10}	V_{20}
1960	507	290	1960

The voltage results are especially worth noting, in the context of what a power quality monitor would report in such an installation, depending upon its point of connection.

- From the (impossible) high voltages of the 100 Ω baseline (no SPDs), the voltage that would be recorded by a monitor installed at the service entrance is now reduced to “only” 1960 V.

- A **voltage-only monitor** installed at the point of use of the power (typical selection of point of installation in many surveys), namely the two receptacles at 5 m and 10 m feeding the PCs, would report respectively 510 V and 290 V, **creating the illusion (fallacy) that there is no significant surge activity** at these points.

- In reality a current surge I_5 of nearly 2000 A is carried by the PC rectifier into the capacitor, via a line fuse. Such a high current — **undetected by a voltage-only monitor** — could very well be fatal for the rectifier or the input fuse, or for the capacitor of the PC power port. Such failures were found in post-mortems of equipment recently performed at PEAC. That scenario is also what occurred in the experimental test of Section 3 for a 4 kV open-circuit voltage and capacitor-MOV combination (shown in next-to-last row of Table 1).
